TECHNICAL REPORT REMR-CO-3

**CASE HISTORIES OF CORPS BREAKWATER
AND JETTY STRUCTURES**

Report 3

NORTH CENTRAL DIVISION

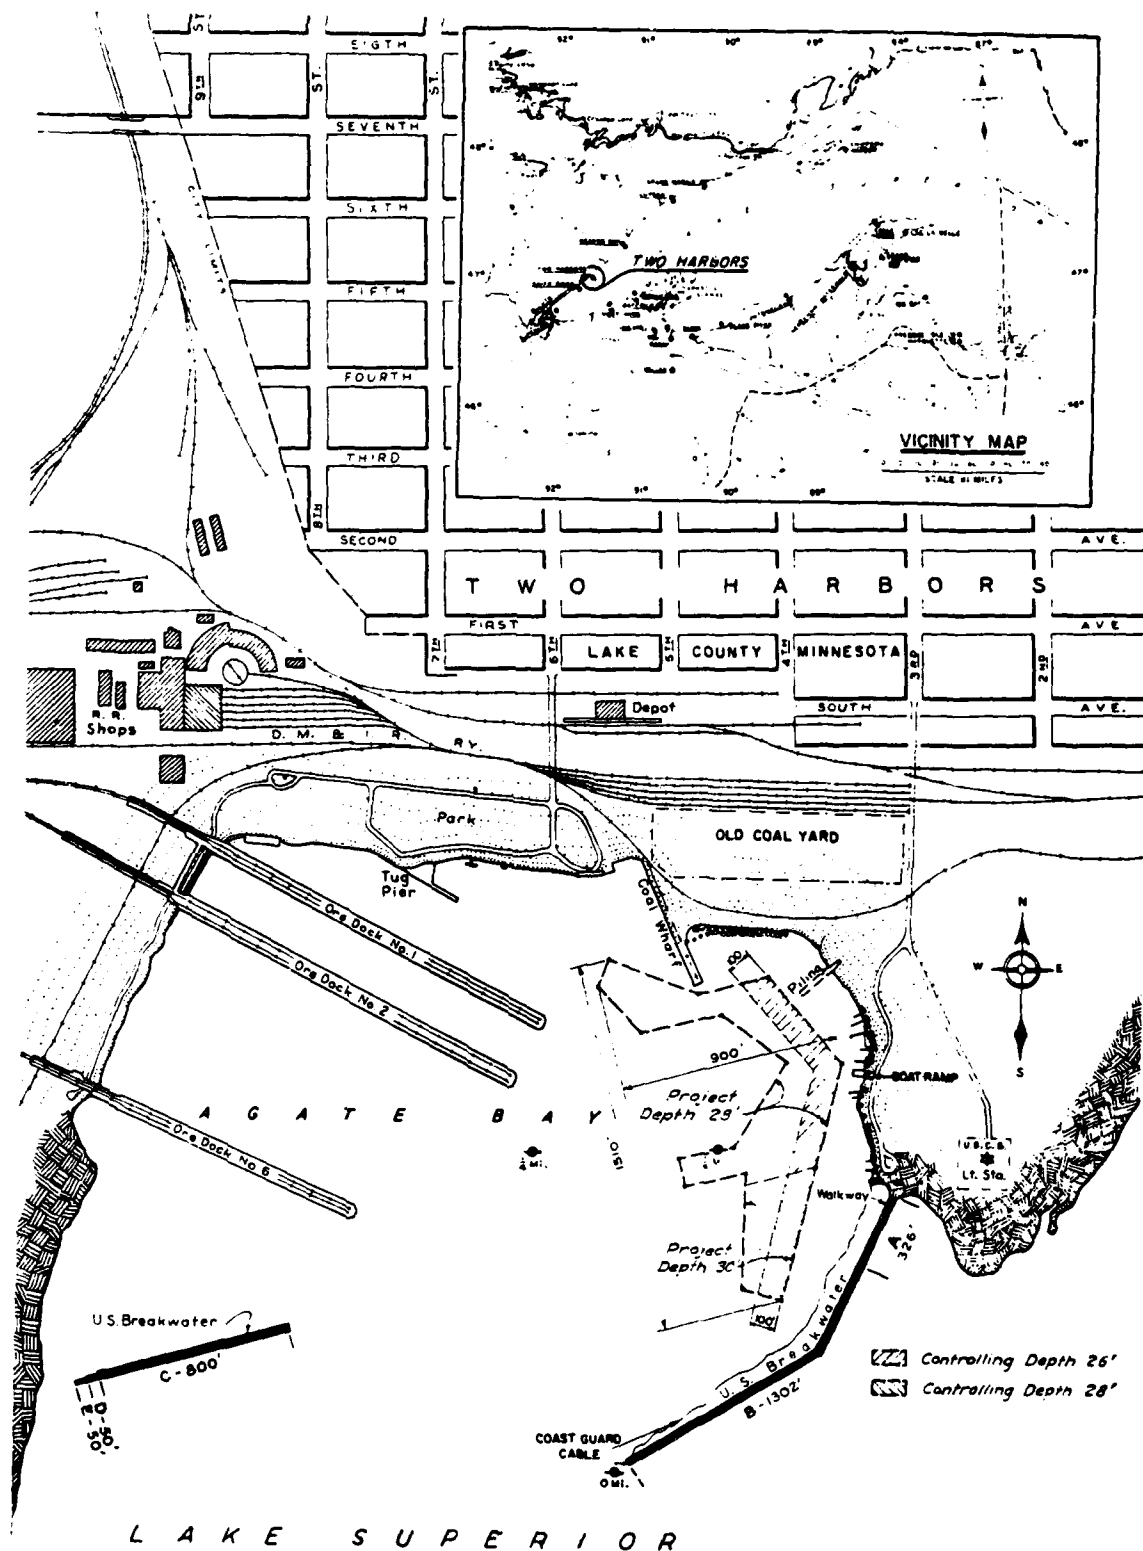
Figure 7: Two Harbors, Minnesota

Date(s)	Construction and Rehabilitation History
1893	Construction of a 900-ft-long stone-filled timber crib breakwater (Figure 7, Sections C, D, and E) was completed at the site. The cribs were built on rubble-mound foundations. The easternmost 800 ft of the structure was 24 ft wide (Figure 8, Section C), the adjacent 50-ft portion was 20 ft wide (Figure 8, Section D), and the westernmost 50 ft of the breakwater was 16 ft wide (Figure 8, Section E).
1933- 1934	A concrete cap (superstructure) was built on the breakwater. The crest el was +7 ft lwd (Figure 8, Sections C, D, and E).
1947- 1949	A 1,302-ft-long stone-filled timber crib breakwater on a rubble-mound base was constructed (Figures 7 and 8, Section B). The structure was 30 ft wide. The rubble-mound base consisted of 5-ton cover stone on 1V:1.5H side slopes.
1948	Construction of a 326-ft-long rubble-mound shore connection of the east breakwater was completed (Figures 7 and 8, section A). The crest was 12 ft wide with a +6 ft crest el.

1948- 1950	A concrete cap (superstructure) was built on the 1,302-ft-long breakwater that was completed during 1947-49 (Figure 8, Section B). The crest el of the structure was increased to +8 ft.
1986	Since construction, records indicate that localized damage of the breakwaters has occurred and has been repaired during routine maintenance. The structures are presently in good condition.

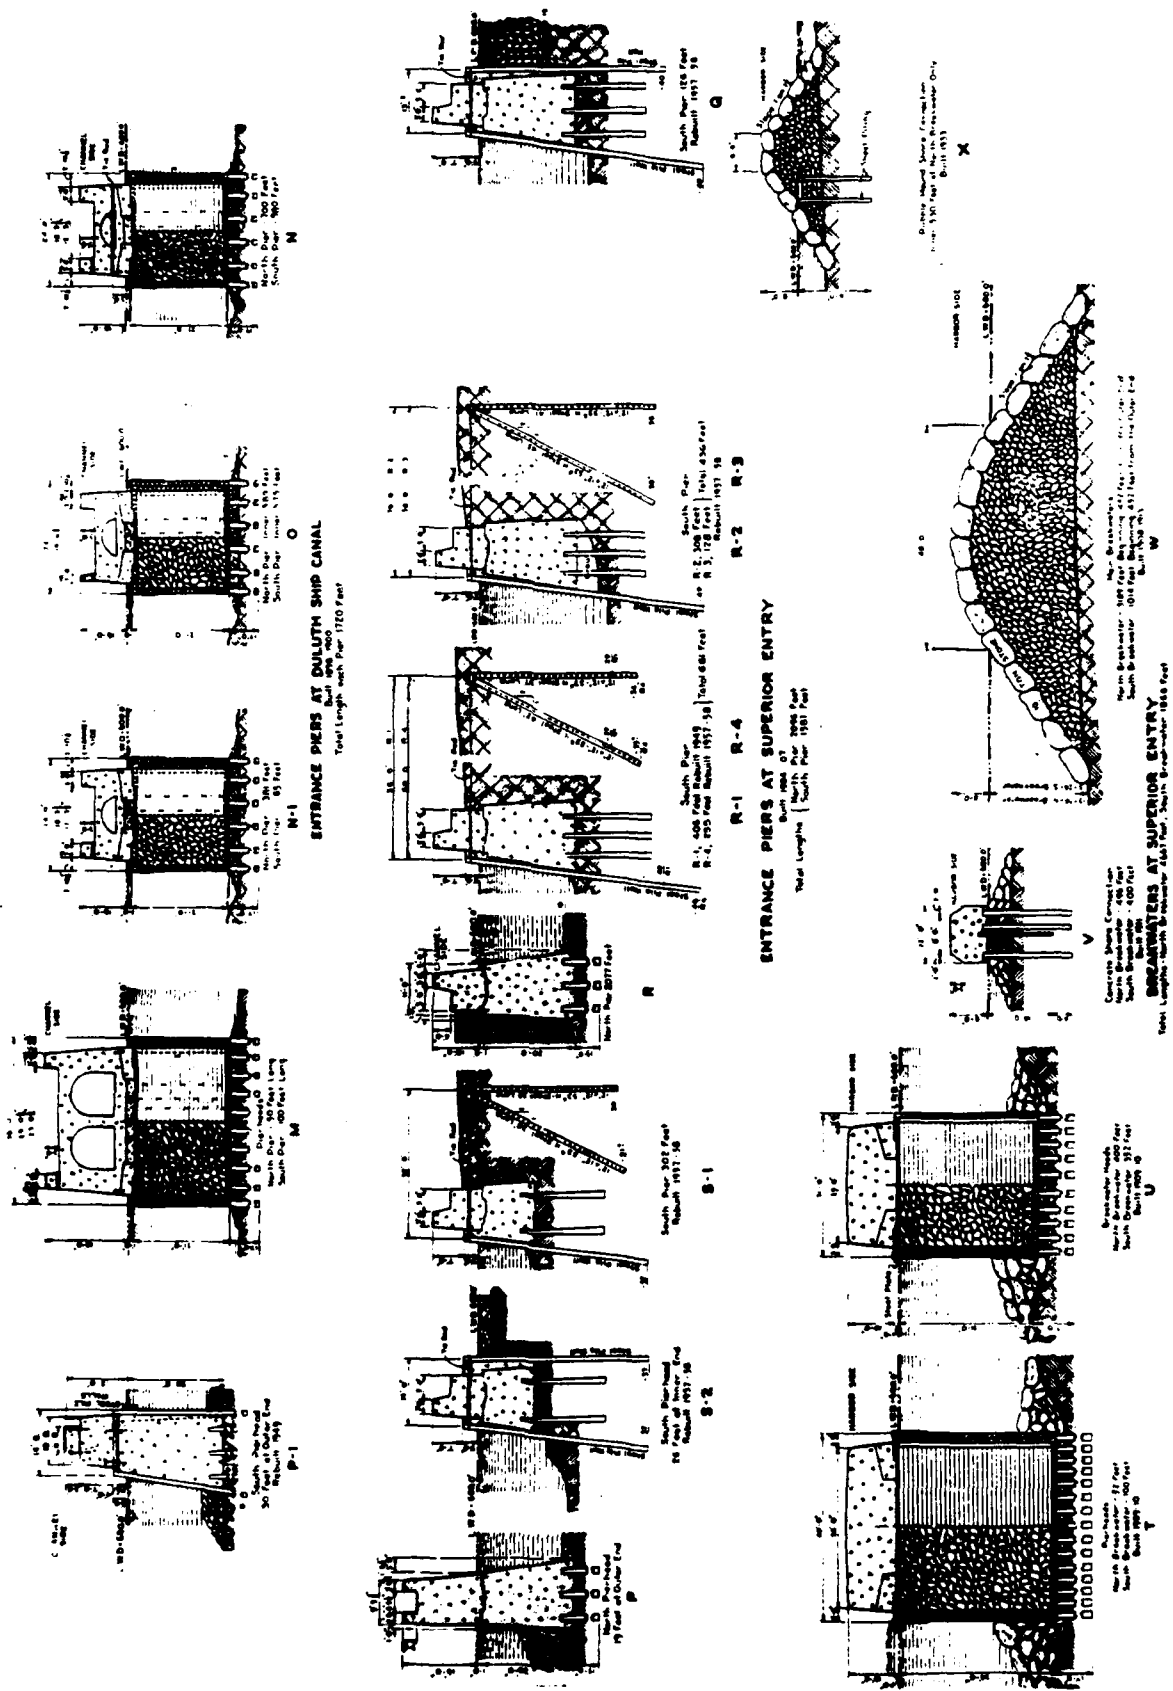
Figure 12. Typical pier cross sections, Duluth-Superior, Minnesota and Wisconsin

1986	In general, very little maintenance has been needed since construction of the project. Minor patching of spalling concrete has been attempted with generally poor results. The structures overall are presently in fair condition.

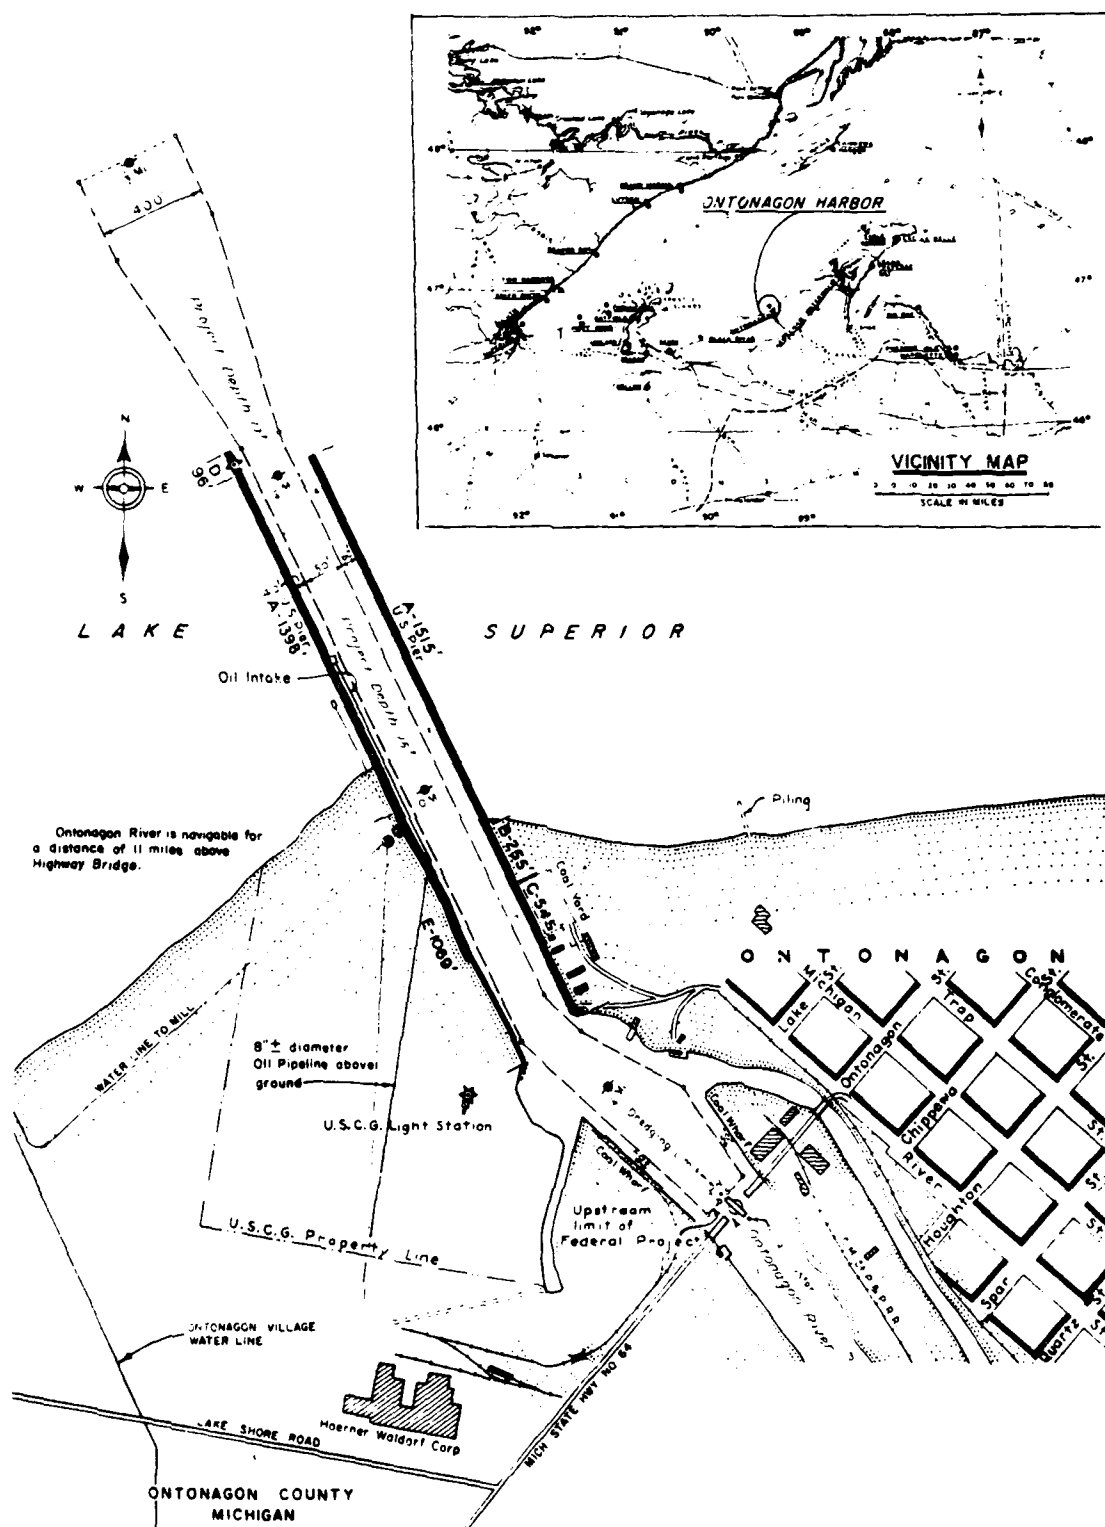
Figure 28. Ontonagon Harbor, Michigan

1983	A structural inspection of the piers was made. A void up to 20 ft wide was observed on the west pier, and sand was being lost through the cribbing under the superstructure. Additional stone was required

Date(s)	Construction and Rehabilitation History
	at various locations on both piers, and it was noted that the concrete superstructure had spalled in areas. In the summer of this year, core and cover stone were placed where necessary to repair the structures.
1986	The piers presently are in fair condition. An aerial view of Ontonagon Harbor piers is shown in Figure 30.

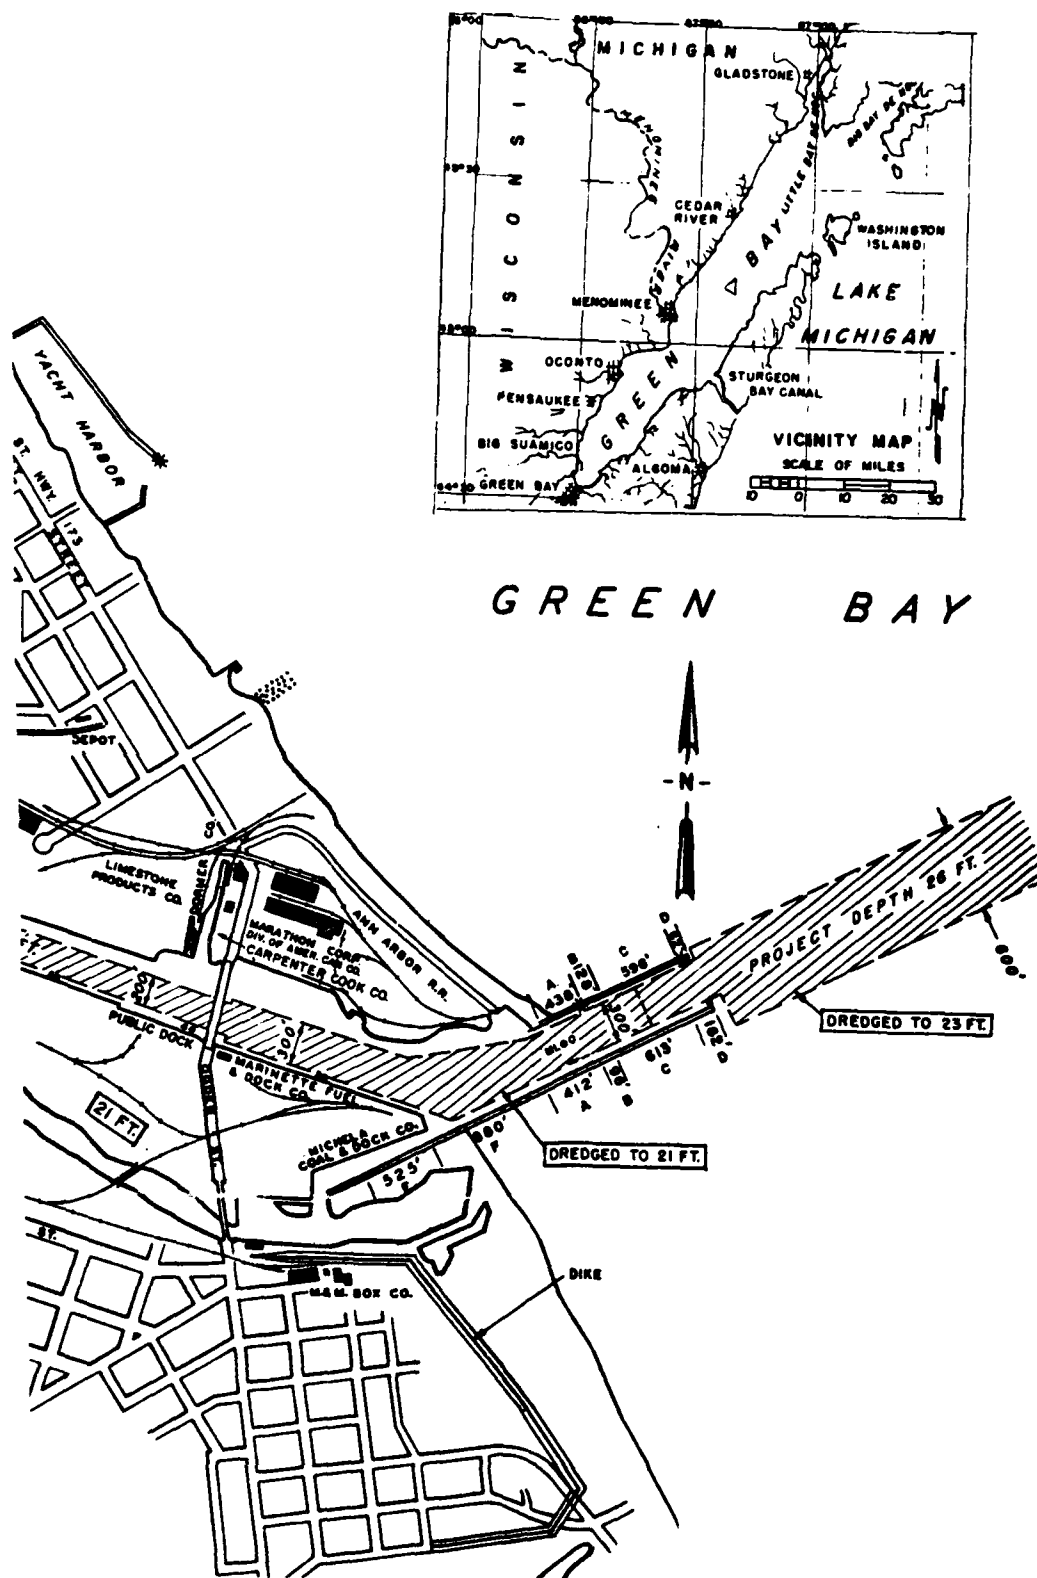
Figure 63. Menominee Harbor, Michigan

1954	The cellular sheet pile at the lakeward end of the north pier was repaired (Figure 63, Section D).
1955	A 613-ft-long section of the south pier was repaired (Figure 63, Section C).
1963	Repairs were made to a 508-ft-long section of the south pier (Figure 63, Sections A and B) and a 1,164-ft-long portion of the north pier (Figure 63, Sections A, B, and C).
1965	An 880-ft-long portion of the south pier was repaired (Figure 63, Section F).
1974	The cellular sheet-pile north pierhead was again repaired (Figure 63, Section D).
1977	The lakeward end of the south pier (Figure 63, Section D) experienced some settlement and was observed slightly leaning toward the channel. Additional riprap placement was completed in the area.
1982	A site inspection of the structures indicated that the north pier was in very good condition and that the south pier was generally in good condition. The settlement of the lakeward end of the south structure (Figure 63, Section D) appeared to have stabilized since placement of the riprap in 1977. The concrete superstructure of the portion of the pier needed maintenance however.

1986	The piers have experienced reconstruction, repairs, and maintenance during their lifetime, and they presently are considered in good condition.

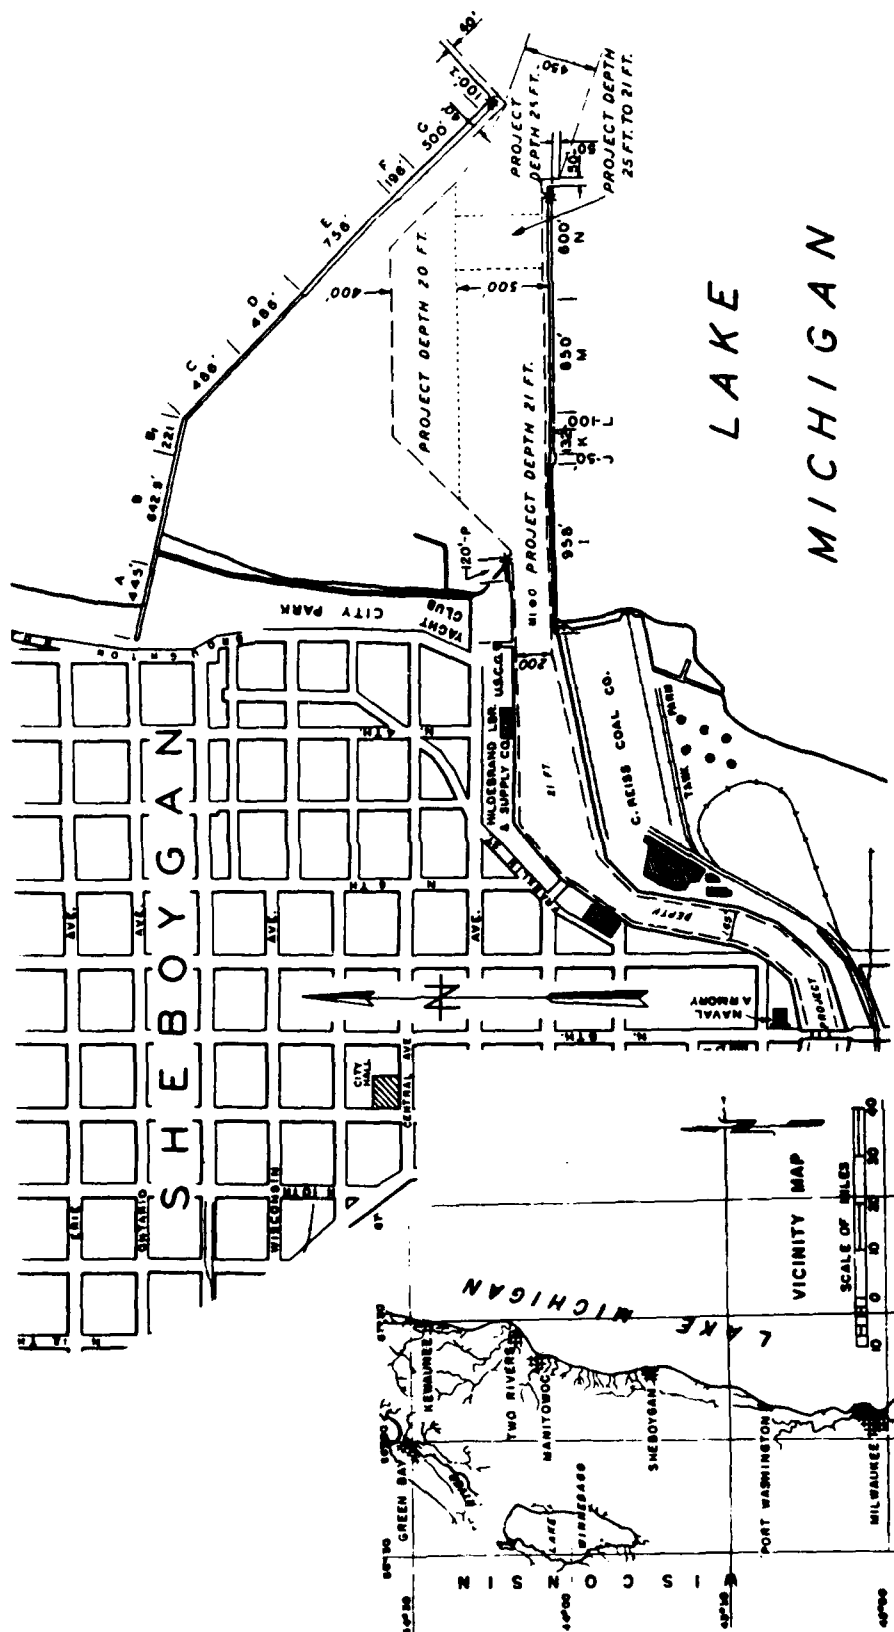
Figure 77. Sheboygan Harbor, Wisconsin

1964	The 958-ft-long shoreward end of the south pier was repaired (Figure 77, Section I), and the north pier was rebuilt (Figures 77 and 78, Section p). Steel sheet piles were driven on each side of the existing north pier forming a width of 23 ft. The voids were filled with stone and concrete to an el of +7.3 ft lwd. An 843-ft-long portion of the north breakwater also was repaired during this year (Figures 77 and 79, Sections B and B1). Riprap was installed to the el of the superstructure (+7.1 ft lwd) on both sides of Section B with 1-V:1.5-H side slopes. Stone was installed over Section B1 to an el of +6.75 ft lwd. The crest was 20 ft wide, and the stone was grouted in place. Side slopes were 1V:1.5H.
1980	Toe stone was placed along the outermost section of the south pier (Figure 77, Section N) to stabilize settling of the structure. Concrete repair work was completed on the north pier.

1984	A site inspection of the south pier indicated the channel side of the structure was in good condition. Fill rock was needed, however, in some areas, and the concrete cap was leaning toward the channel in one area.
1986	The structures presently are considered to be in good condition overall.

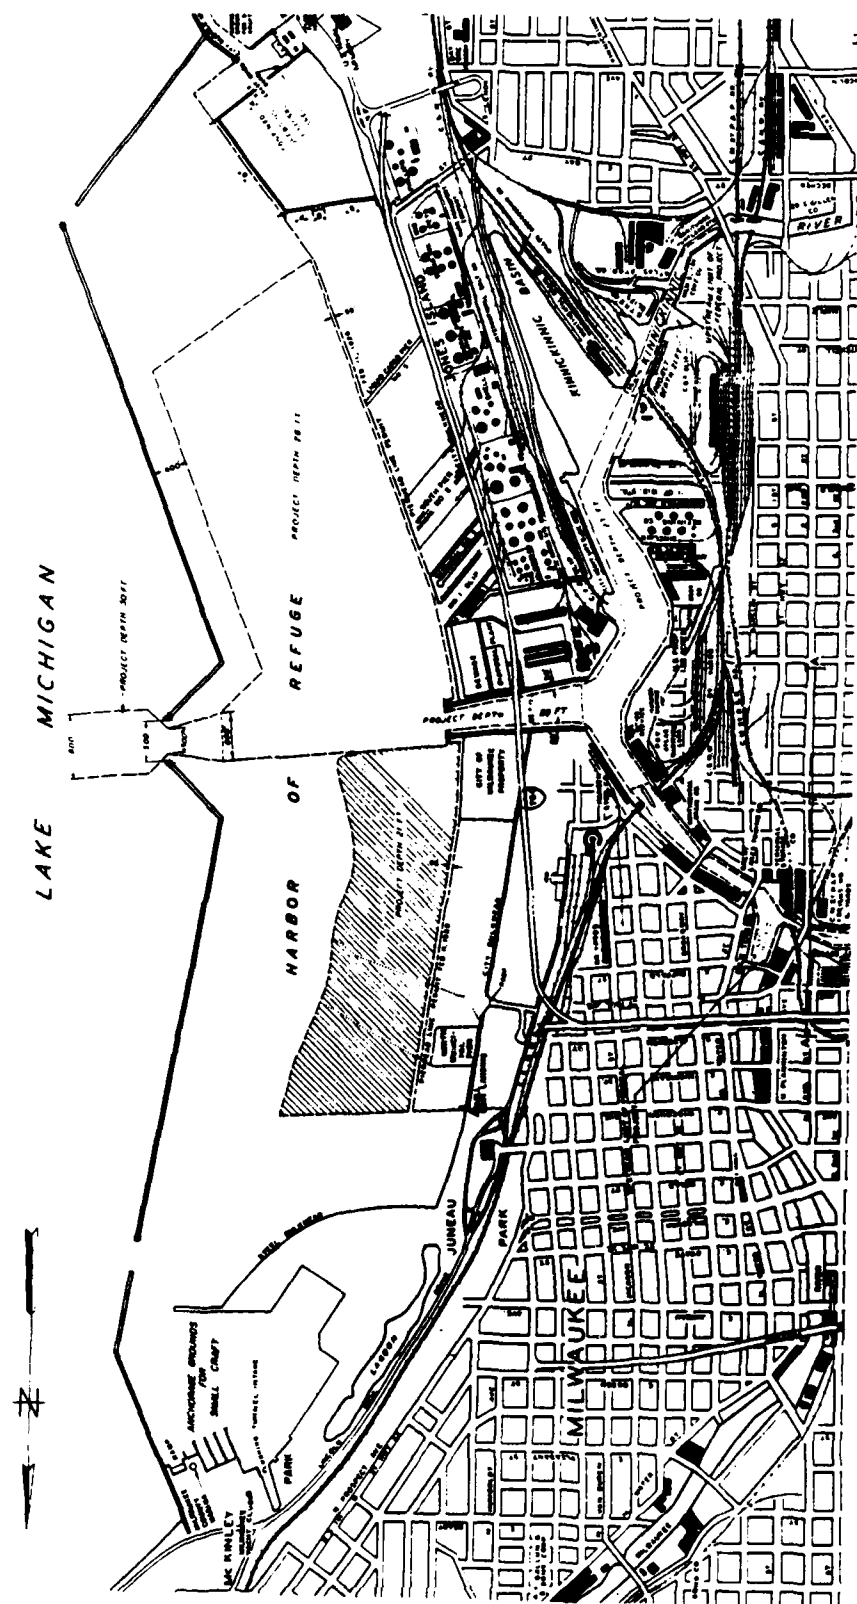
Figure 85. Milwaukee Harbor, Wisconsin

1984	A site inspection of the north breakwater revealed some sections in good shape and others requiring repair and maintenance.
1985	Repair of the head of the south breakwater was completed for a cost of \$810,942. A new caisson was constructed and capped with concrete. Stone, ranging from 3 to 6 tons, was placed around the new caisson for toe protection.
1986	The breakwaters and piers are presently considered to be in fair condition.

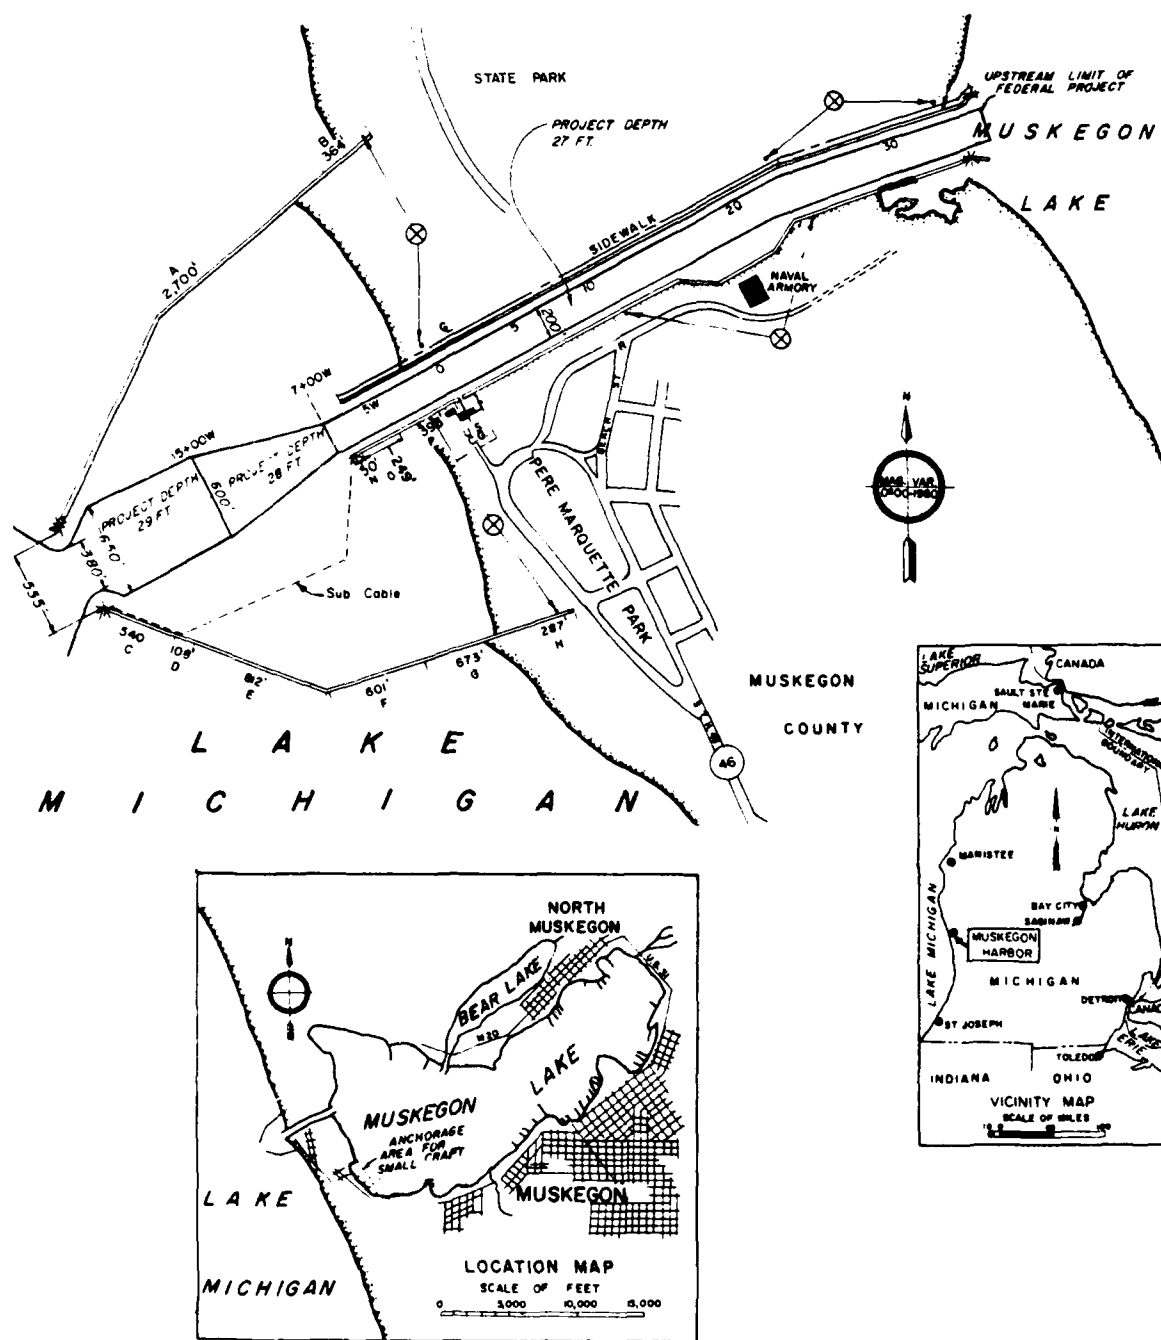
Figure 130. Muskegon Harbor, Michigan

1984	Major riprap placement at the south breakwater (Figure 130, Sections C, D, and E) for protection against waves and ice action was completed which involved approximately 86,770 tons of 10- to 26-ton cover stone (with stones as large as 49 tons in some areas). This placement encompassed the south breakwater head and both the lake and harbor sides. The stone was placed to an el of +8.0 ft lwd.
1986	Reconstruction of the head of the north breakwater was initiated and involved (Figure 130) removal of the existing cover and core stone and the placement of a steel sheetpiling with a concrete cap breakwater head structure. Also initiated was rehabilitation of the south breakwater concrete caps which are extensively spalled with large pieces cracked and broken off causing a hazard to the public. After these repairs, the structures will be in good condition. An aerial view of Muskegon Harbor structures is shown in Figure 133.

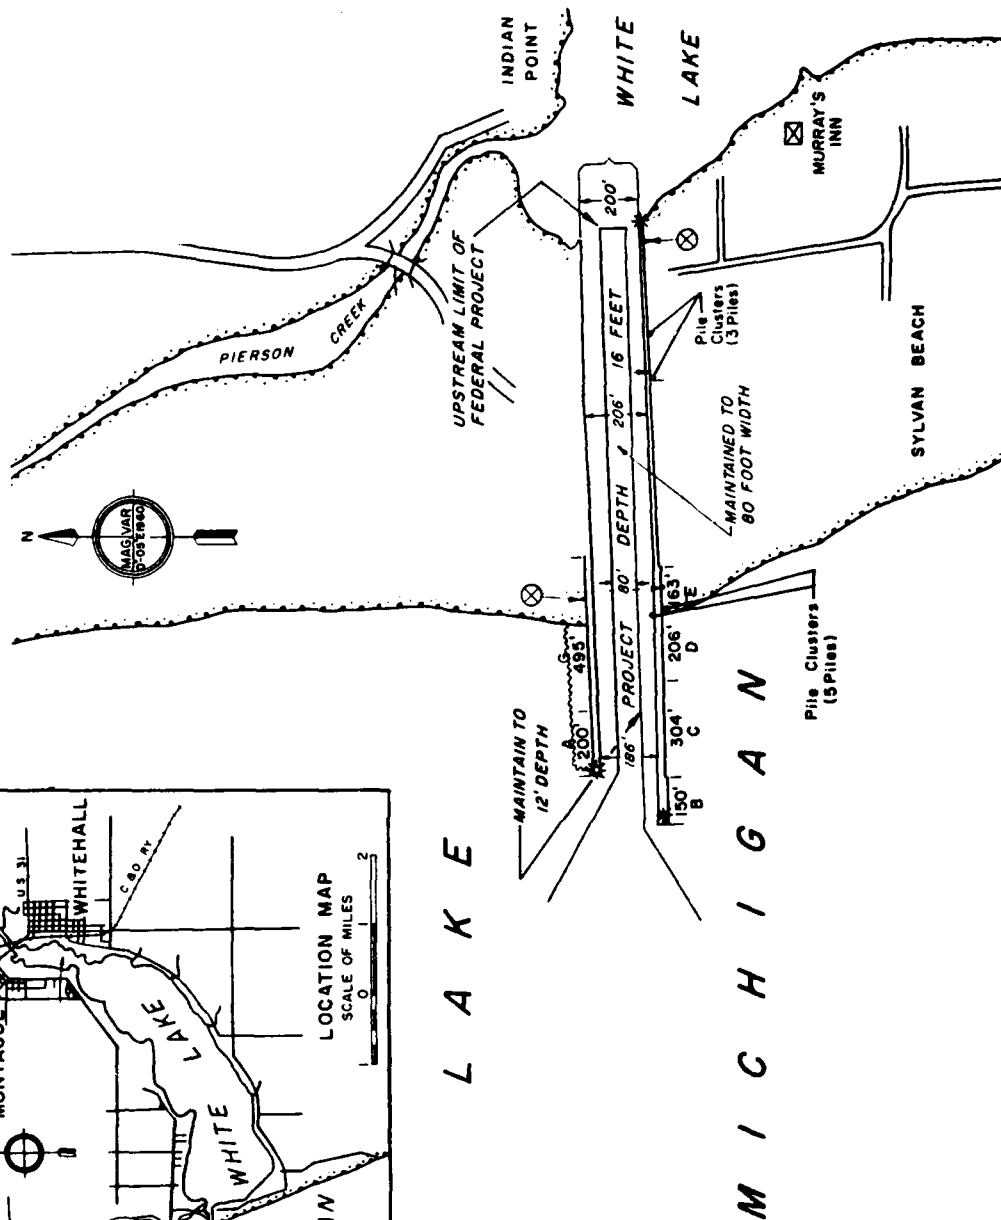
Figure 134. White Lake Harbor, Michigan

1985	An inspection of the structures indicated that the substructures of both piers are deteriorating, resulting in superstructure settlement and cracking, considerable misalignment and tilt, and loss of fill stone. Both structures are considered to be in poor condition. Reconstruction and/or rehabilitation has been recommended within the next 2 to 3 years.

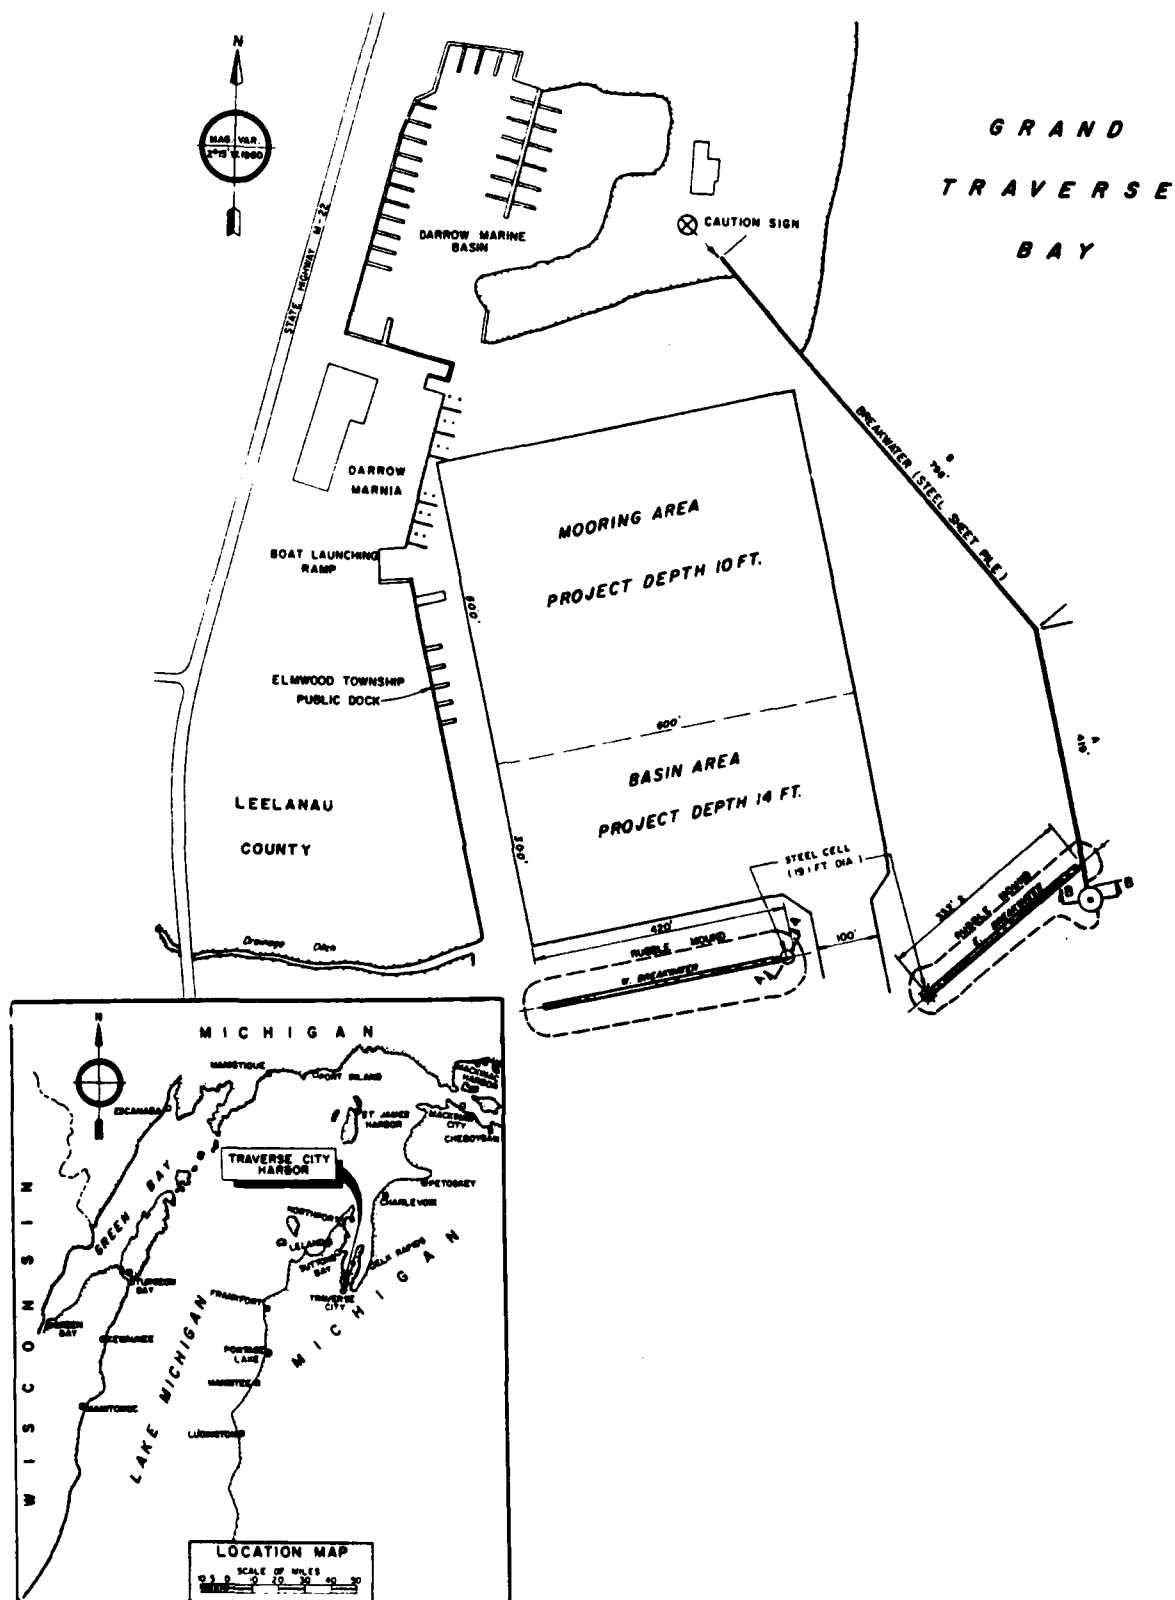
Figure 160. Greilickville Harbor, Michigan

1976	Stone was placed into a washed out area of the east end of the east breakwater (Figure 160).
1979	Stone was placed along both sides of the steel sheet-pile breakwater (Figure 160, Sections A and B) to reduce scouring and maintain structure stability.
1985	A site inspection of the breakwaters indicated that the rubble-mound east and west breakwaters were deteriorating slightly, with stones cracking and breaking into smaller pieces as a result of the low-grade limestone used in initial construction. Rehabilitation with sounder and slightly larger cover stones has been recommended. The breakwaters, however, were considered to be in good stable condition. An aerial photo of Greilickville Harbor breakwaters is shown in Figure 162.
1986	Traverse City Harbor was renamed "Greilickville Harbor," on 17 October 1986, in the 99th Congress, 2nd Session, Title XIII, Section 1304.
